SAFETY BULLITEN

Silo Safety on Aran ASR 200 and ASR 280B Mobile Pugmill

Caution: prevent free fall of silo while being lowered.

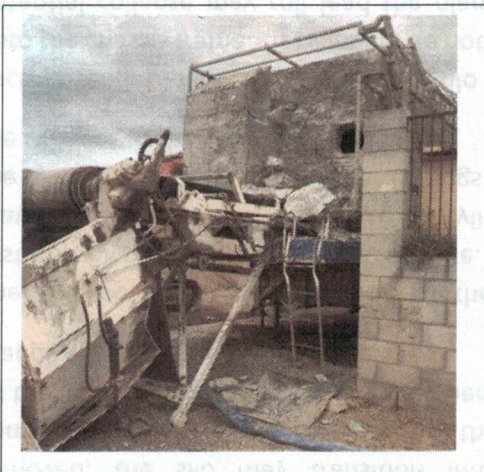
The silo is designed so that it can be lowered in preparation for moving the pugmill using a prime mover of a semitrailer.

Whilst the silo is lowered there is a risk of free fall onto the discharge conveyor.

- Ensure all Aran ASR 200 and ASR 280 mobile pug mills have been fitted with hose burst protection valves.
- Ensure the silo is empty and all material removed from the roof before lowering.
- If it is suspected that air may have entered the hydraulic system, use the bleeder on the cylinder to release any air.
- Access for this task must be risk assessed to ensure all the effective controls are in place.
- Maintain a No-Go zone during raising or lowering the silo.

All modern Aran mobile plants have remotely operated locking pins to restrain the silo whilst mechanical support braces are removed. Upgrading older plants is possible and assessable on individual case basis.

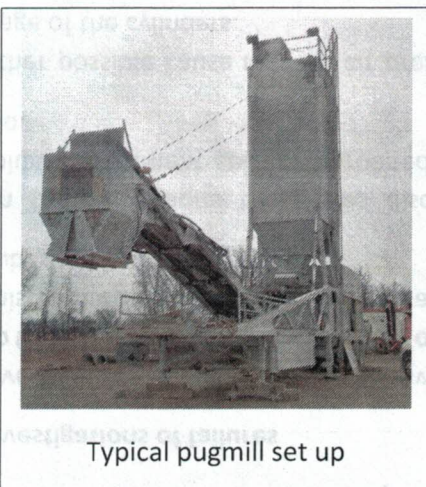
Typical pugmill set up

The silo is raised and lowered using two single acting telescoping hydraulic cylinders.

The cylinders, cradled in the chassis of the plant chassis are attached to gussets that are welded to the frame of the silo.

The silo is hydraulically elevated and then lowered under gravity. The silo pivot is offset such that it will fall forward if there was no restraint.
